Single Event Effects and Their Mitigation at the Collider Detector at Fermilab

R.J. Tesarek
Fermilab

Operational Problems

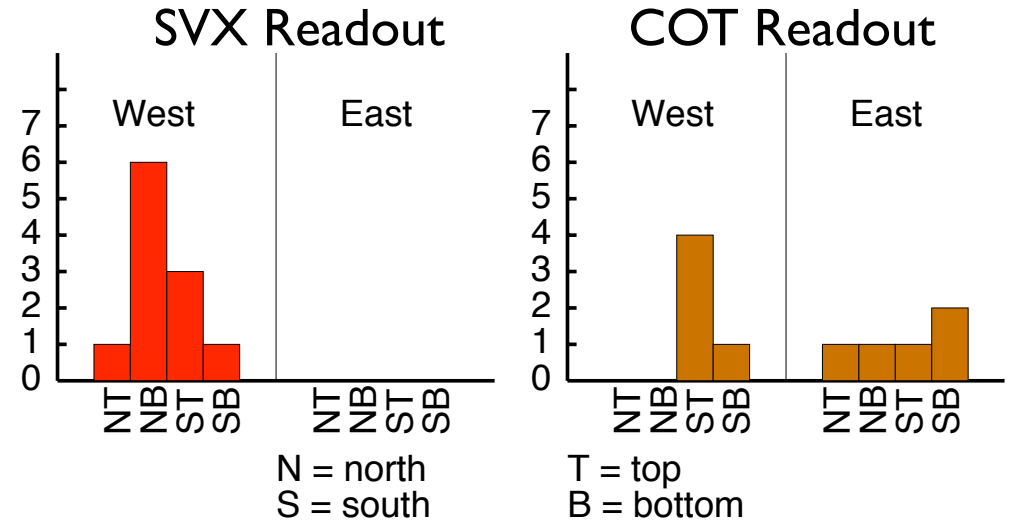
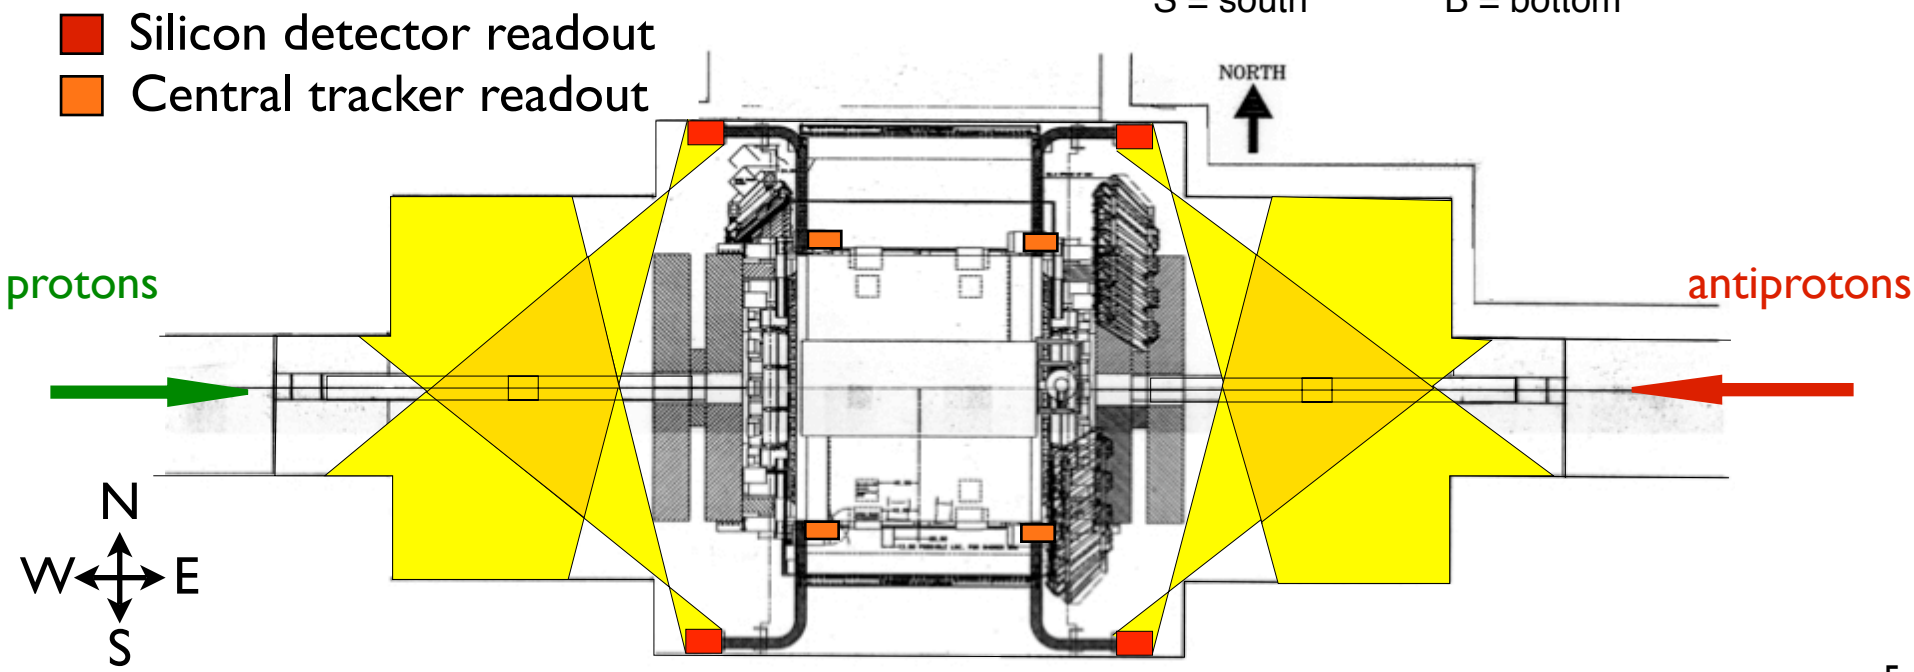
Failure Locations

Failure Characteristics

- Position Dependent
- Beam Related

Experiments show focusing quads are a line source of radiation

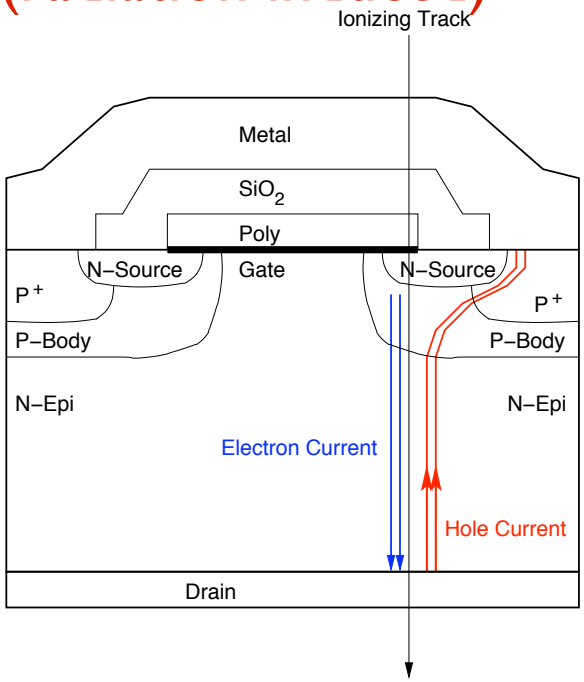
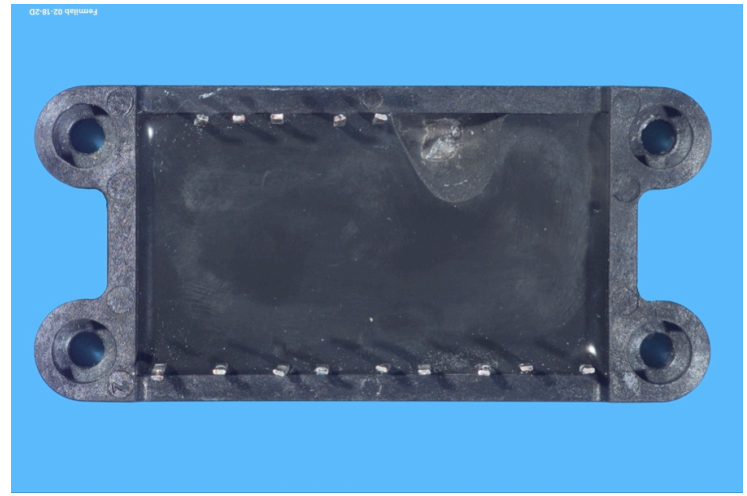
Power Factor Corrector Circuit

Most failures were associated with high beam losses or misaligned beam pipe

> Power MOSFET SEB (radiation induced)

epoxy covering fractured

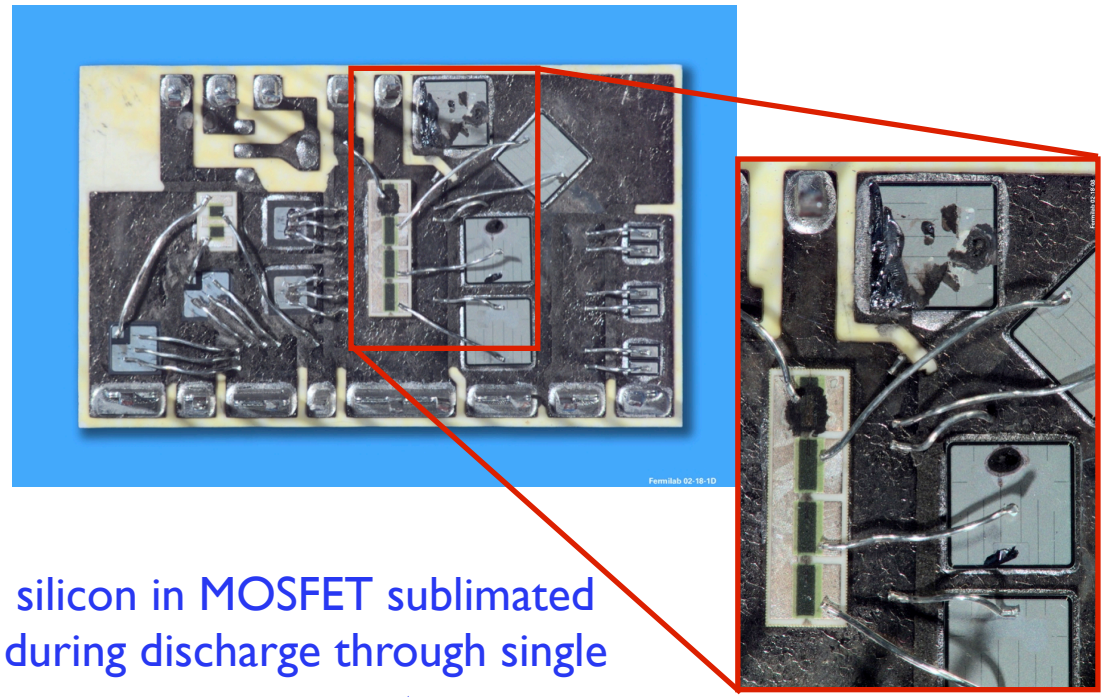
silicon in MOSFET sublimated during discharge through single component

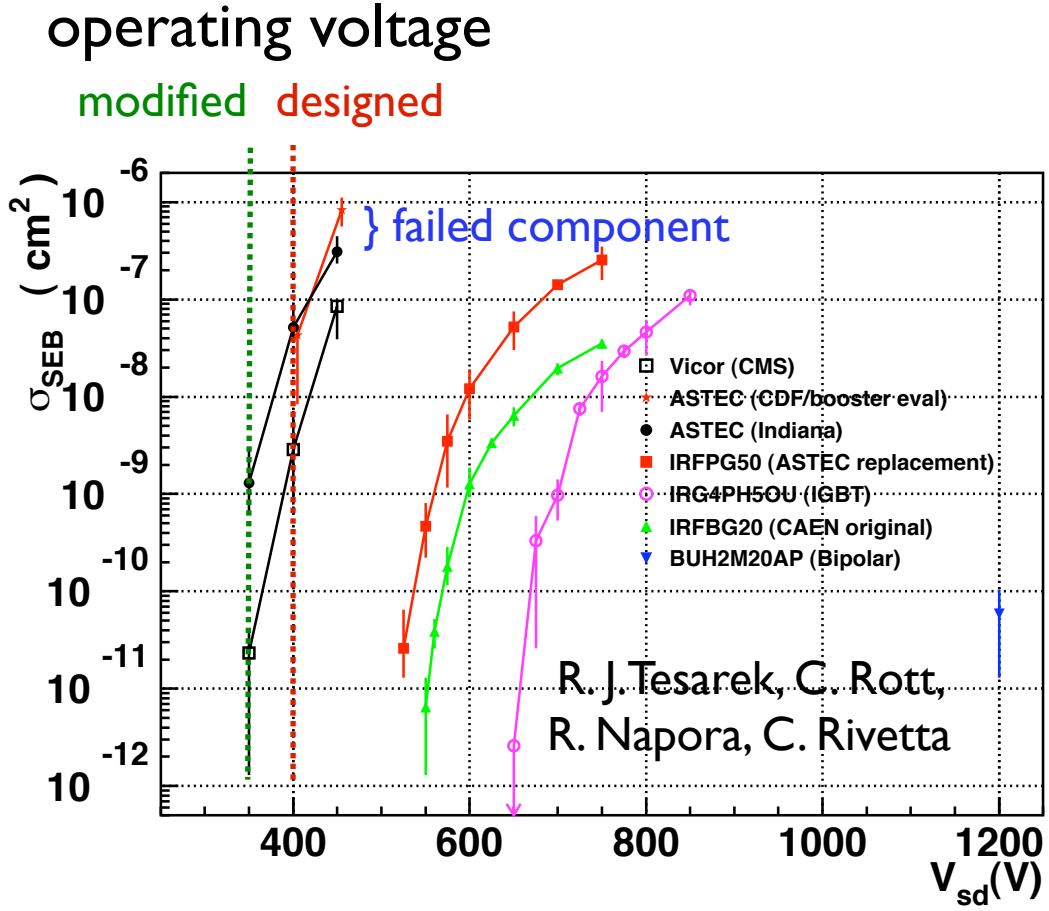
SEB cross section measurement

- catastrophic
- beam related
- damage at low doses
- depends on bias voltage

Test beam data, 200 MeV protons
Indiana Cyclotron

Solution (lower Vbias)

- Factor of 50 reduction in radiation sensitivity
- No failures in > 2 years operation

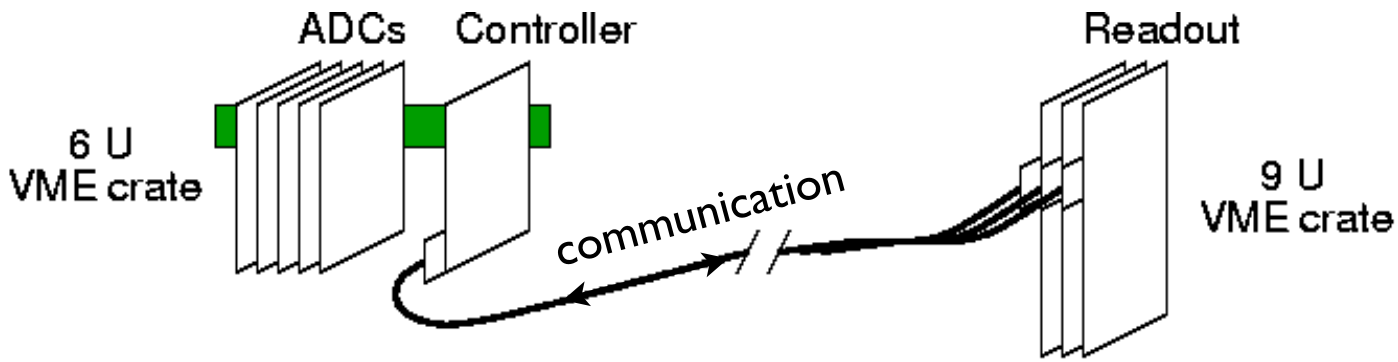
Shower Maximum (SMX) Readout

Communication lost in system

- only occurs for systems in highest radiation areas
- requires power cycle to recover
- ram based calibrations must be restored (re-calibration)
- 30 minute recovery time
- failed component not yet identified (2700 FPGAs)

Modify procedures to always write calibrations to non-volatile (FRAM) memory

- recovery time reduced to few minutes.

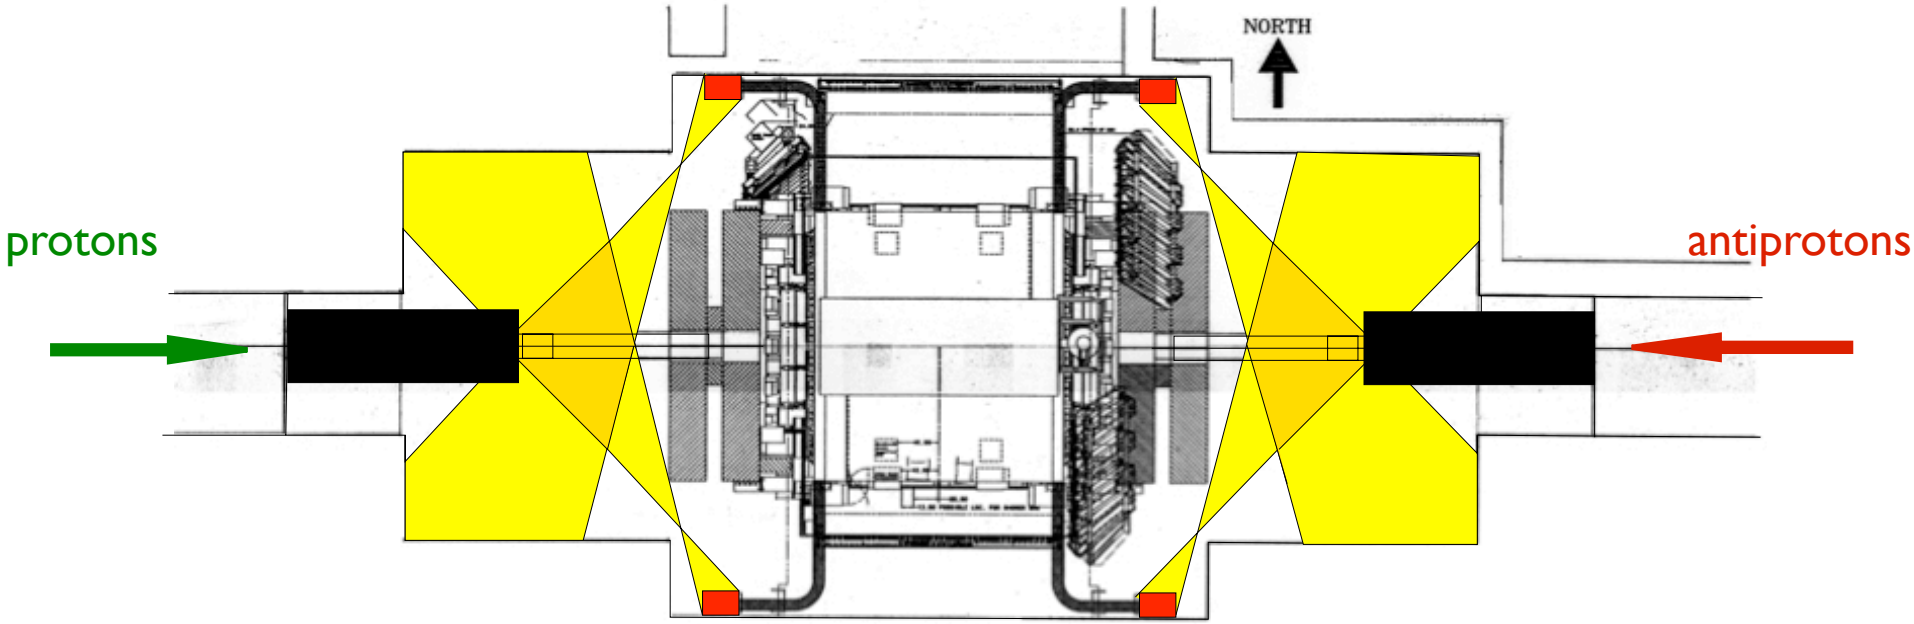
CDF Detector w/ additional shielding

Scintillation counter measurements show low beta quadrupoles form a line source of charged particles.

Power supply failure analysis shows largest problem on the west (proton) side of the collision hall.

Shielding reduces ionizing radiation by 25%

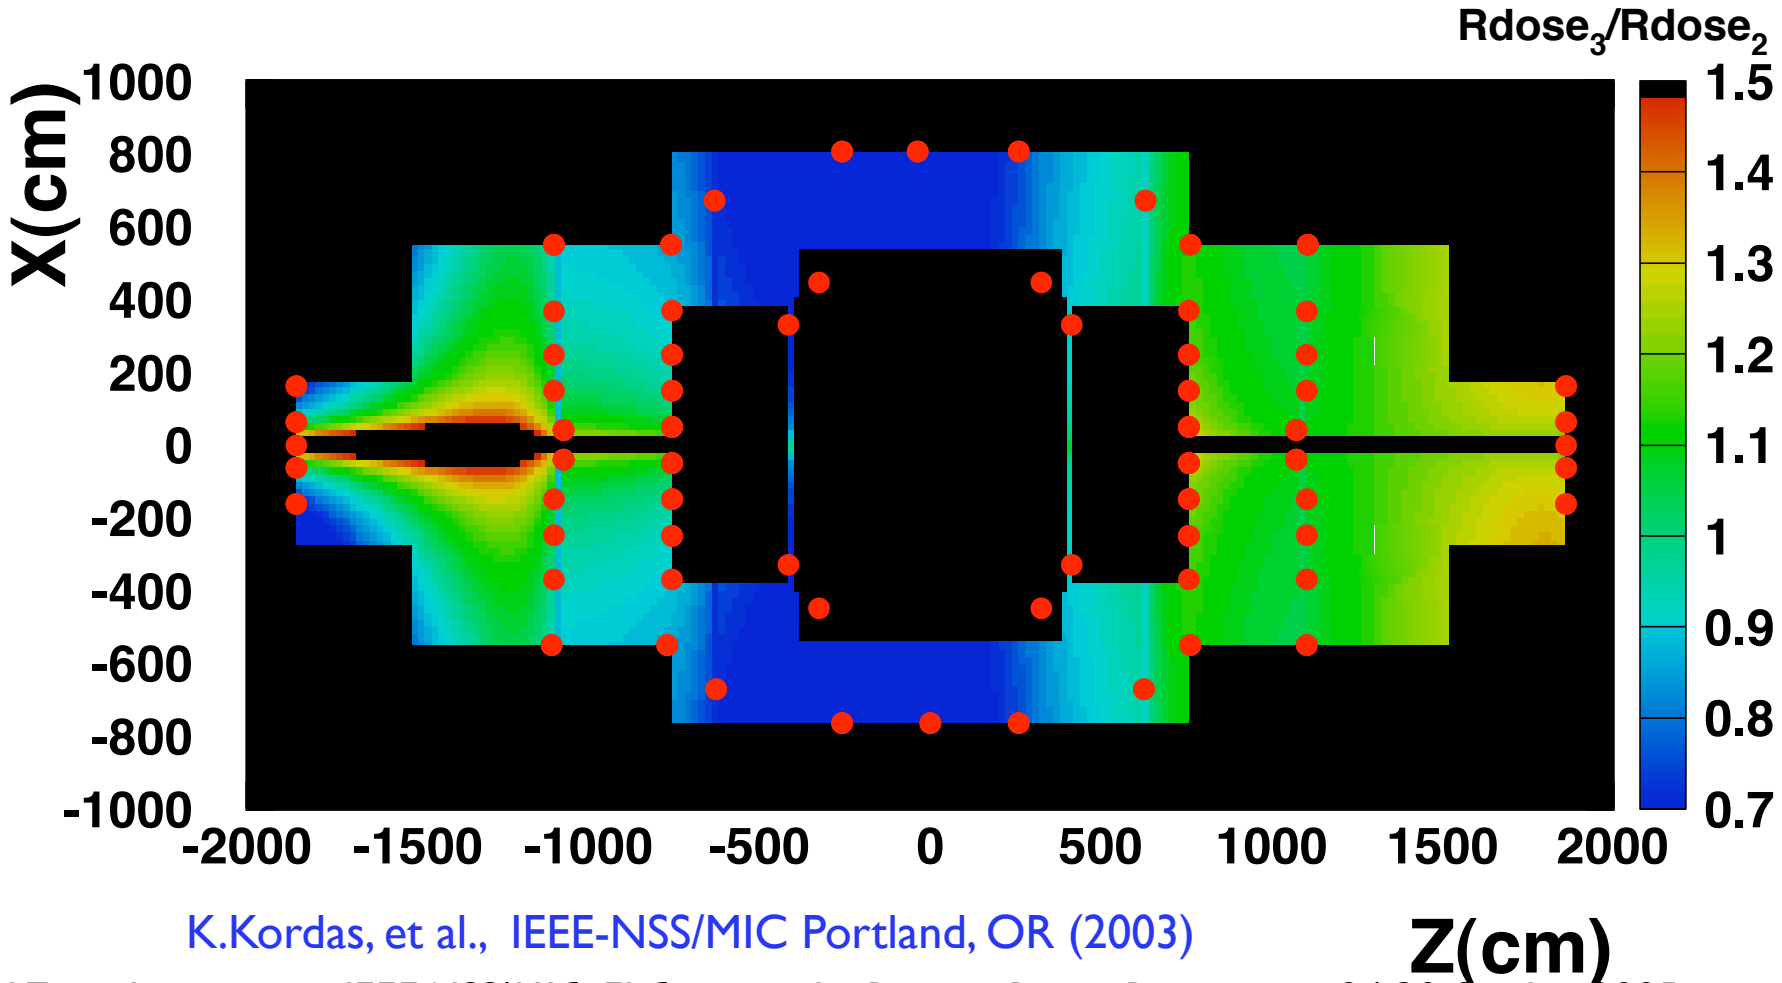
Collision Hall Ionizing Radiation Field

Thermal luminescent dosimeter (TLD) measurements
Shielding installed on proton side only.

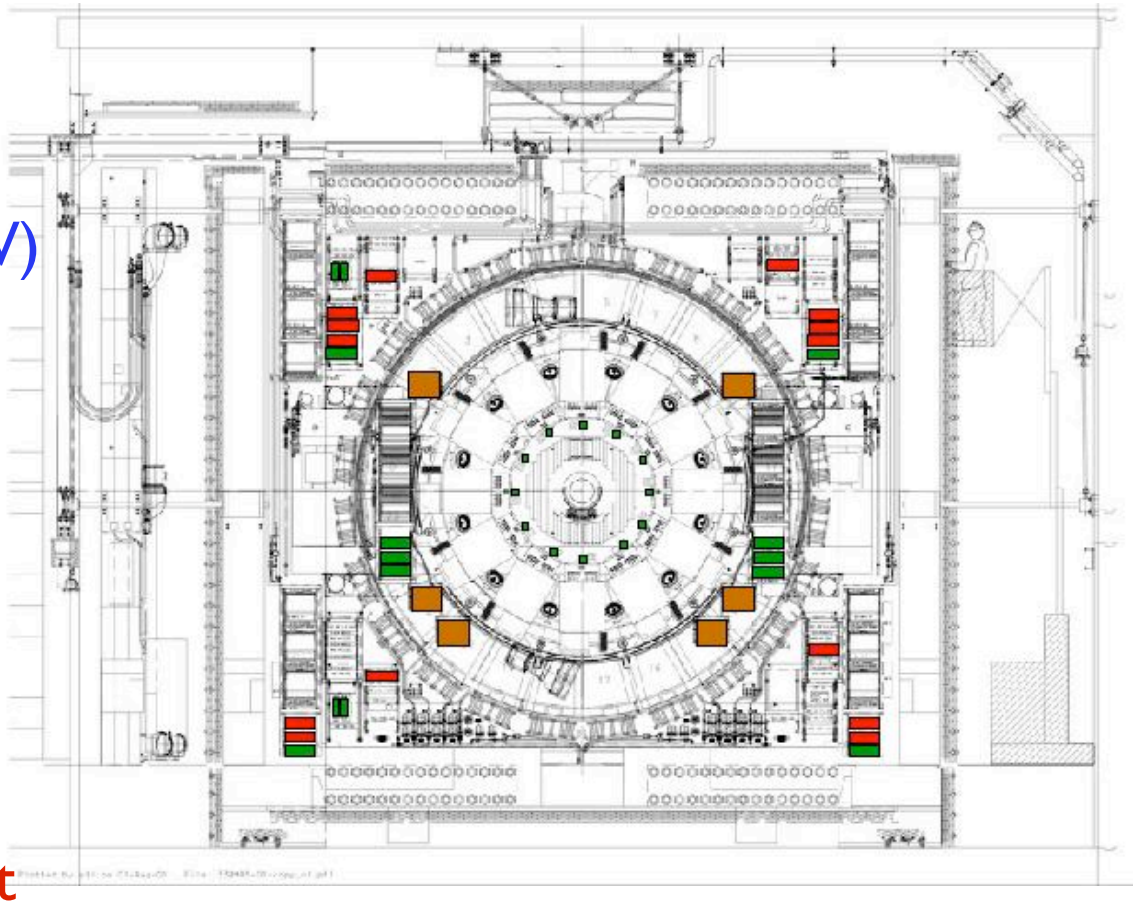
Power Supplies on the CDF Detector

- 36 switching supplies (5kW)
  - 28 "shielded"
- 38 linear supplies (1kW)
  - all "shielded"
- ~200 linear supplies (0.3kW)
  - all "shielded"

"shielded" means no line of sight to beam.

Switching Power Supplies (5kW)
Linear Power Supplies (1kW, 0.3kW)
HV Mainframe
